UNDERWATER BRIDGE INSPECTION REPORT

STRUCTURE NO. 88594
CSAH NO. 44
OVER THE
INDIAN CREEK
DISTRICT 1 – ST. LOUIS COUNTY

PREPARED FOR THE
MINNESOTA DEPARTMENT OF TRANSPORTATION
BY
COLLINS ENGINEERS, INC.
JOB NO. 3512 (CEI 6)

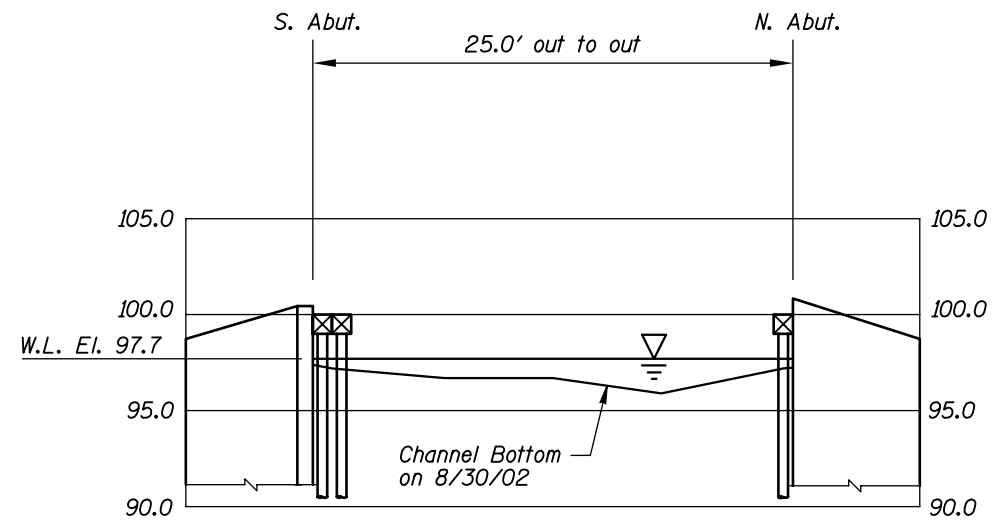
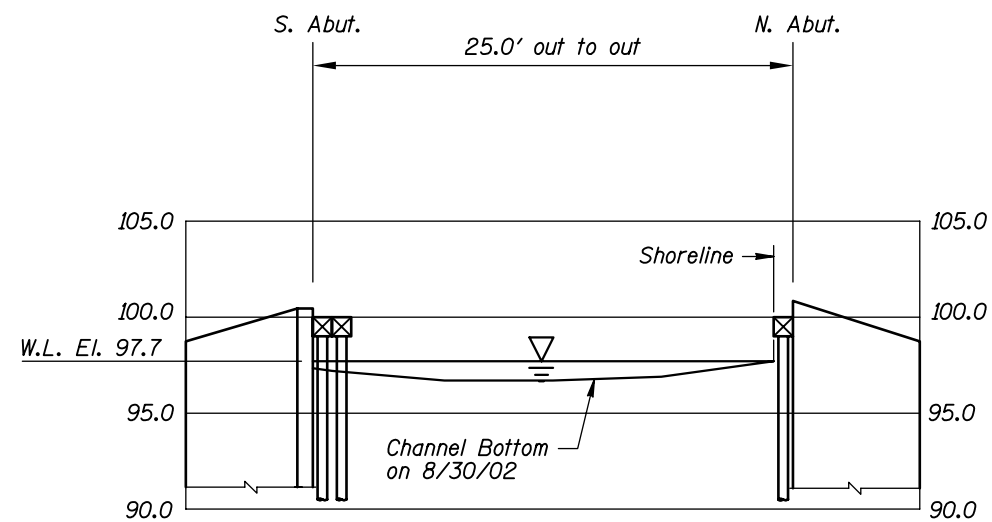
Date: AUG. 2002
Scale: NTS
Figure No.: 1

- ⑤ The timber pile exhibited a 1/2-inch-wide, 1.5-inch-deep split extending from the pile cap to the mudline.
- ⑥ The wingwall has failed and the east end of the backwall exhibited considerable movement with backfill escaping through 1-inch-gaps between the planking.

UPSTREAM FASCIA PROFILE

DOWNSTREAM FASCIA PROFILE
